# Designing a True Maintenance-free Pivot

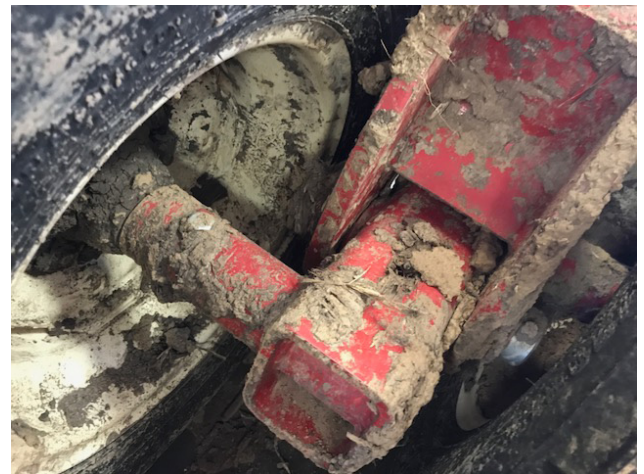
Unlike true maintenance-free designs, legacy designs require substantial downtime. Thus, legacy designs aren't typically considered ideal. Legacy designs are composed of:

- Metallic bushing with grease grooves
- Steel housing with grease zerks
- Steel pin, sometimes hardened depending on the application

- Continuous maintenance (sometimes daily) for the end user
- The cost of grease and replacement parts if not performed regularly is very expensive, i.e.: the pin, bushing, or housing
- External lubrication is required, which attracts dirt and debris from the surrounding environment and creates a sand paper effect on the bushing and pin

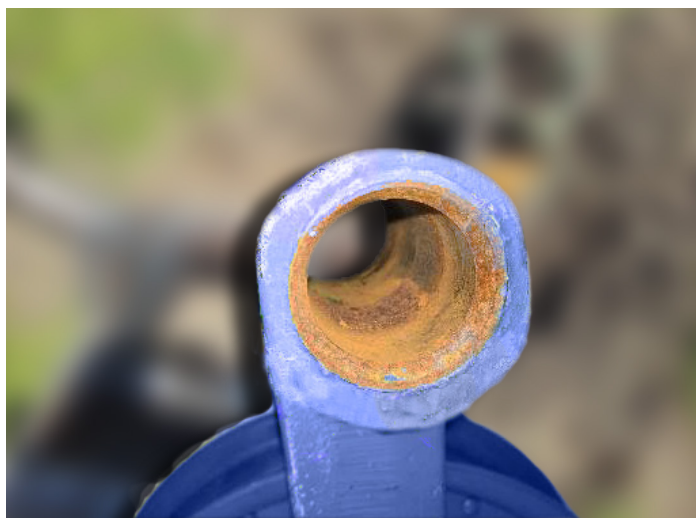
Result of a housing without corrosion protection

### 1. There is no corrosion protection for the housing.

- Corrosion will begin to form almost immediately on the inner portion, where there is no bushing material. This corrosion will flake off and begin to prematurely wear both the bushing and pin simultaneously.
- Corrosion will begin to form between the outer diameter of the bushing and the inner diameter of the housing, which will cause the housing to shrink around the bushing. Doing this will reduce the clearance between the bushing and pin, and increase friction and the wear rate of the bushing.

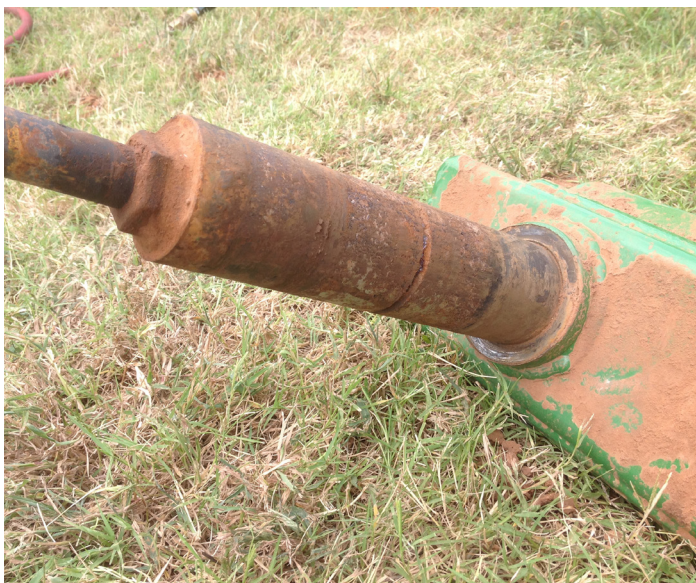
Result of using a thin, ineffective corrosion inhibitor on a shaft after only one season

### 2. The pin will deteriorate at higher rate due to the absence of an effective corrosion inhibitor.

- Commonly used corrosion inhibitors, such as zinc, nickel, and chrome, are very thin layers applied to a pin and are quickly worn off during normal operation.
- Once the inhibitor is removed, the base alloy gets exposed to the environment and the surface finish will become much rougher than any plain bushing can successfully run on.
- This corrosion and degradation of the surface finish may be unnoticeable during continuous operation. However, once the machine is idle for any length of time, the corrosion will be able to expand rapidly, and in some instances, cause the pivot to seize altogether.

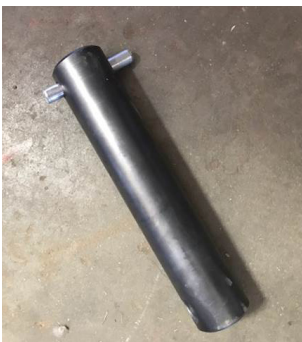
GKF shafting for a walking tandem pivot on a cultivator

**3. A cost effective, high quality, corrosion resistant pin with GKF Shafting:** With GKF shafting, you are able to utilize both a hardened and a corrosion resistant pin. The hardness can be comparable to hard chrome when using the correct base alloy. Also, the corrosion resistance is roughly 3-5 times better than zinc, nickel, or chrome plating. igus® performed salt spray testing in accordance with ASTM B117-16 requirements and achieved 300 hours without any signs of red rust on the main body of the pin. The corrosion-resistant layer is very difficult to wear past since it diffuses into the surface of the pin. The pin would need to suffer roughly 0.020mm of wear in order to penetrate past the inhibitor layer.

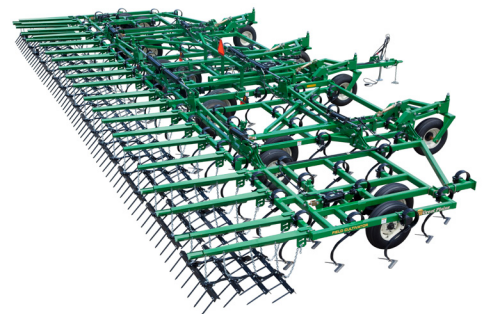
**1. The use of an igus® iglide® dry-running, self-lubricating and maintenance-free bushing:** iglide® bushings are built for long service life and are low in cost. They require no external lubrication, and thus little to no maintenance. iglide® bushings are injection molded from a blend of thermoplastic materials, embedded reinforcing fibers and solid lubricant. The fiber reinforced materials make the bushings strong and resistant to high forces and edge loads, and the solid lubricants help lower the coefficient of friction. They also have a low wear rate, substantial chemical resistance, quiet operation, high load capacity and the ability to operate in extreme temperatures. Additionally, they are dirt, dust, UV and corrosion resistant. iglide® bushings always offer a solution, either from the catalog range or as a custom-made solution.

**2. A synthetic wax-based corrosion inhibitor used to protect the housing bore:** This is the most overlooked aspect of a maintenance-free pivot. Not only does it protect the housing from corrosion, but it also assists in maintaining a press fit for the bushing.
